Manhole Inspection Summary

Manhole # S31Q1_013MH

Insp Date: **2/7/08 8:58 AM**

Location Address: **801 Seagull Ave**

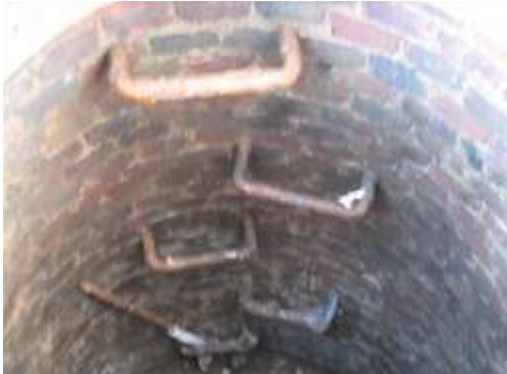
Steps Count: **5** Missing: **0** ☒ Corroded

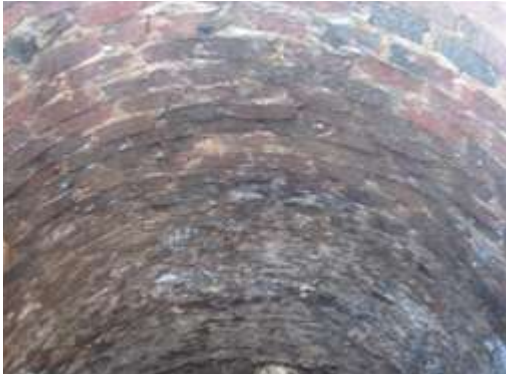
Defect 2

Infiltration: ☐ None ☐ Joint ☐ Cracks ☐ Mortar ☐ Roots ☒ Wall

Wall

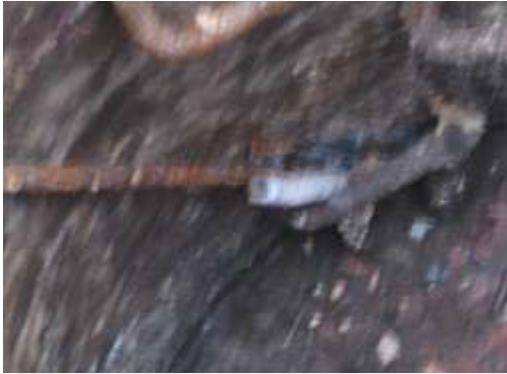
Defect 1

Poles

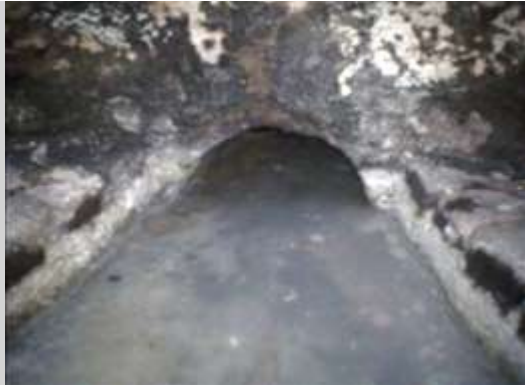
12 O'Clock Outflow

8 in. Circular Gravity Sewer
Pipe Out @ 12 O'Clock

Pipe Height: **9.6** (in.) Rod and Bar (Angled)
Pipe Material: **Clay** ☐ Pipe Lined
Invert Depth: **9.38** (ft.) Flow Characteristics: **Slow**
Deposits: ☒ None ☐ Mud ☐ Sludge ☐ Debris ☐ Grease
Silt Depth: (in.) Deposits Extent:
Infiltration: **None** Pipe Seal Cond: **Sound**

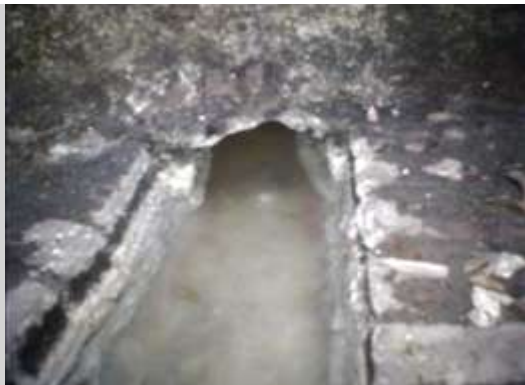
4 O'Clock Inflow

8 in. Circular Service Sewer
Pipe In @ 4 O'Clock

Pipe Height: **7.2** (in.) Rod and Bar (Angled)
Pipe Material: **Clay** ☐ Pipe Lined
Invert Depth: **9.18** (ft.) Flow Characteristics: **Slow**
Deposits: ☒ None ☐ Mud ☐ Sludge ☐ Debris ☐ Grease
Silt Depth: (in.) Deposits Extent:
Infiltration: **None** Pipe Seal Cond: **Sound**

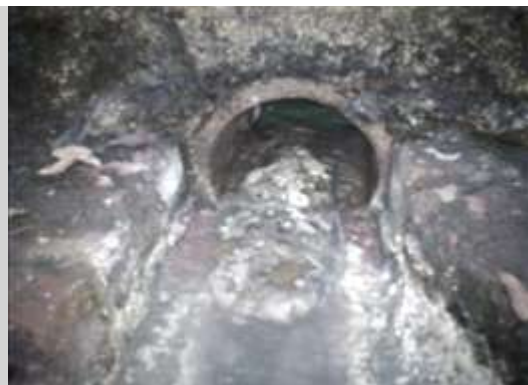
9 O'Clock Inflow

6 in. Circular Gravity Sewer

Pipe In @ 9 O'Clock

Pipe Height: **7.2** (in.) Rod and Bar (Angled)

Infiltration: **None** Pipe Seal Cond: **Sound**
